TRANSPORTATION RESEARCH CENTER

**ON-SITE PASSIVE BELT INVESTIGATION**

CASE NO. - 96-23  
FLEET - PRIVATE VEHICLE  
LOCATION -  
ACCIDENT DATE - 1996

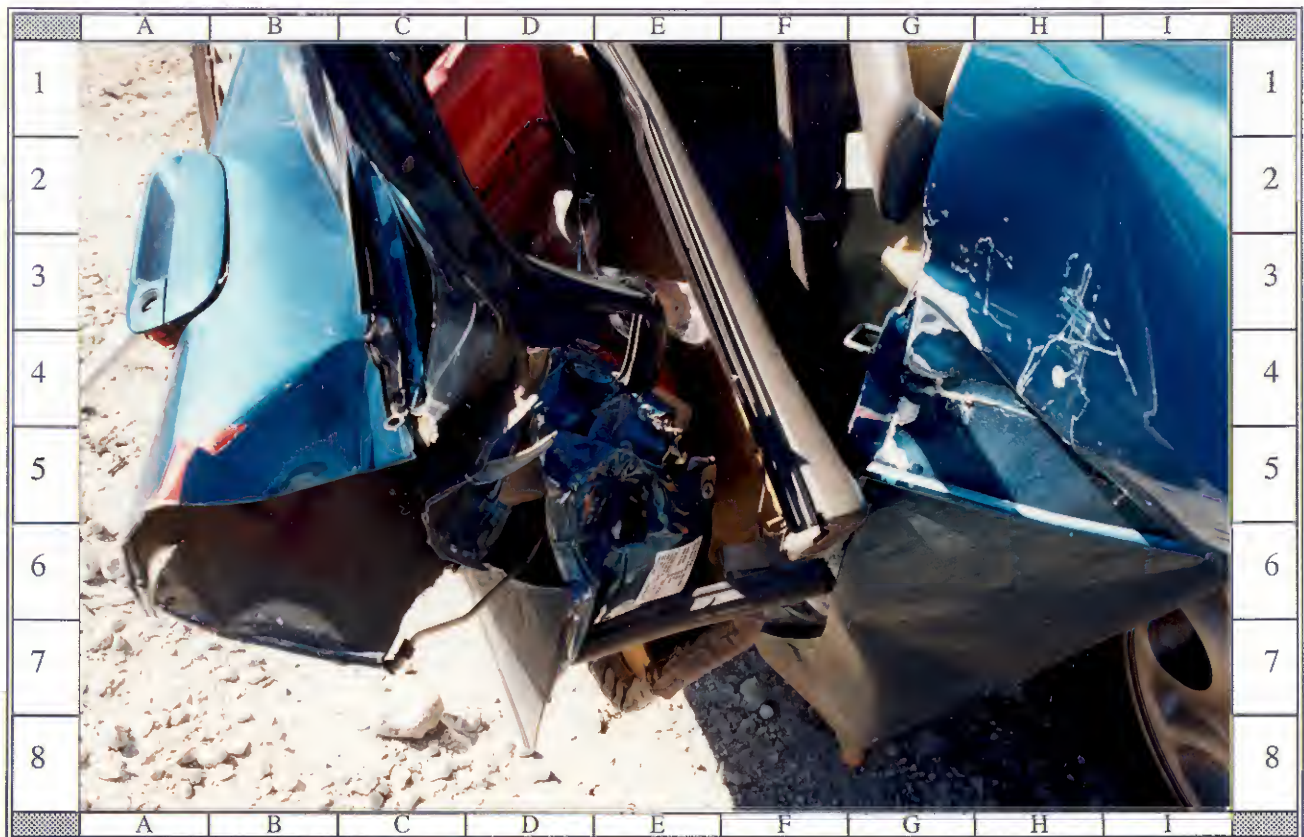
# 42: Vertical close-up of Case Vehicle's driver side door frame and "B"-pillar area showing damage caused by rear wheel intrusion and failure of welds

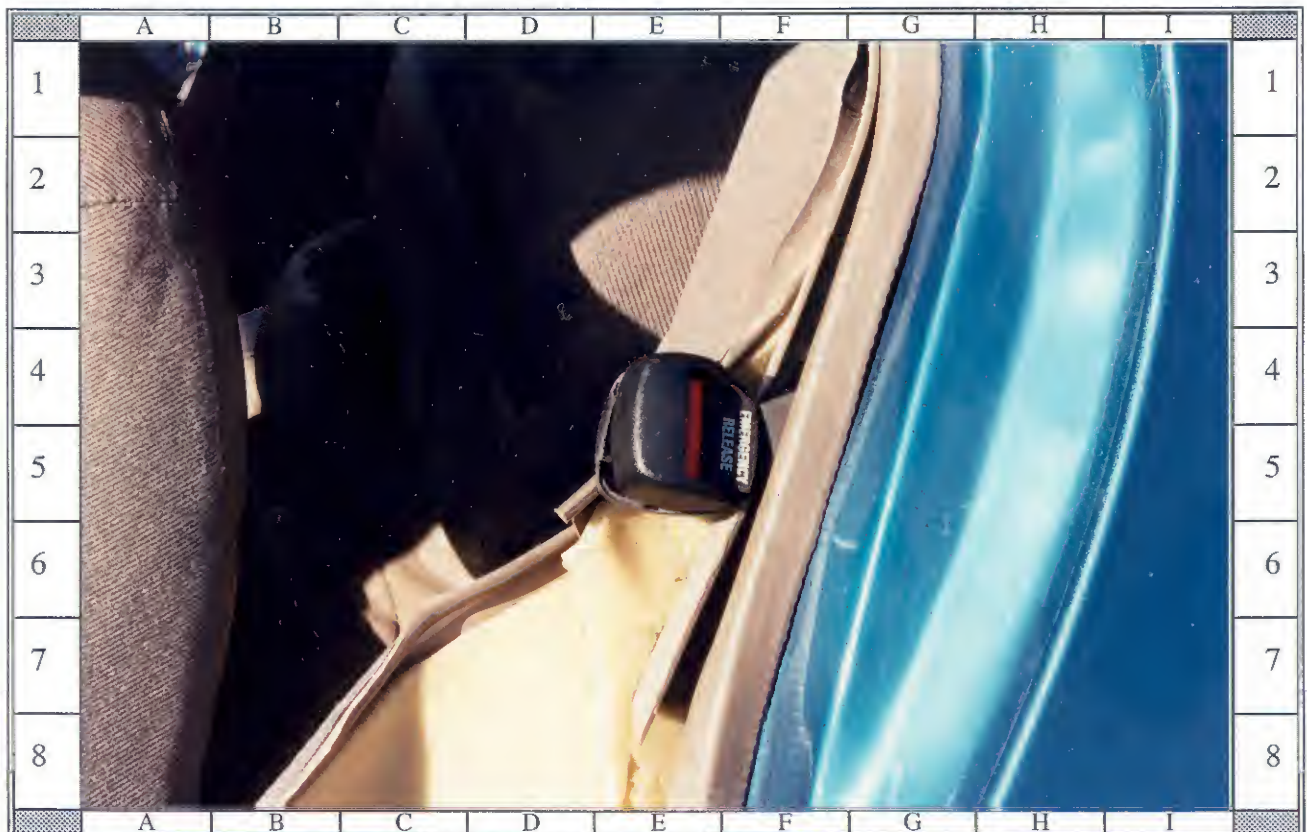
# 49: Close-up of possible skin transfer to webbing of Case Vehicle's driver side, manual, two-point, lap belt

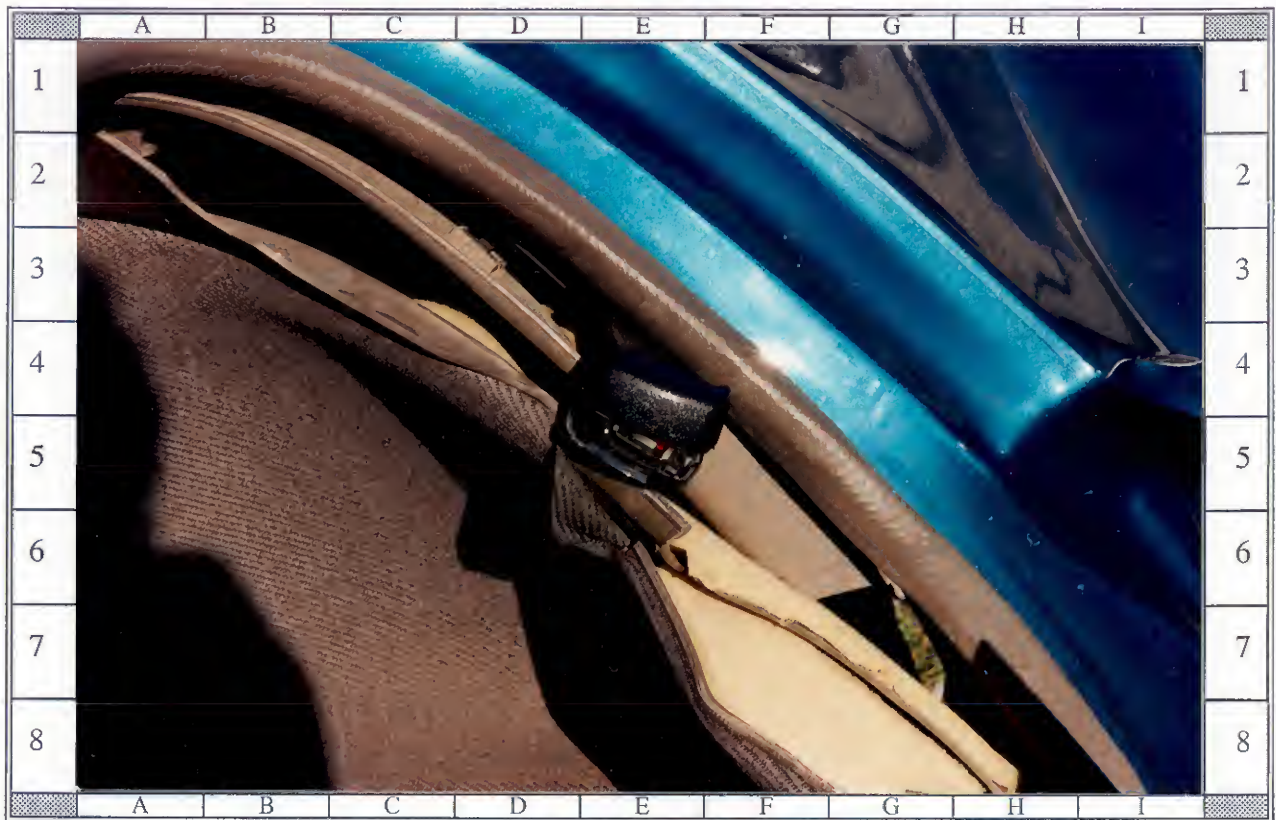
# 50: Close-up of Case Vehicle's broken driver side motorized torso belt connector viewed from left; compare with photograph #41

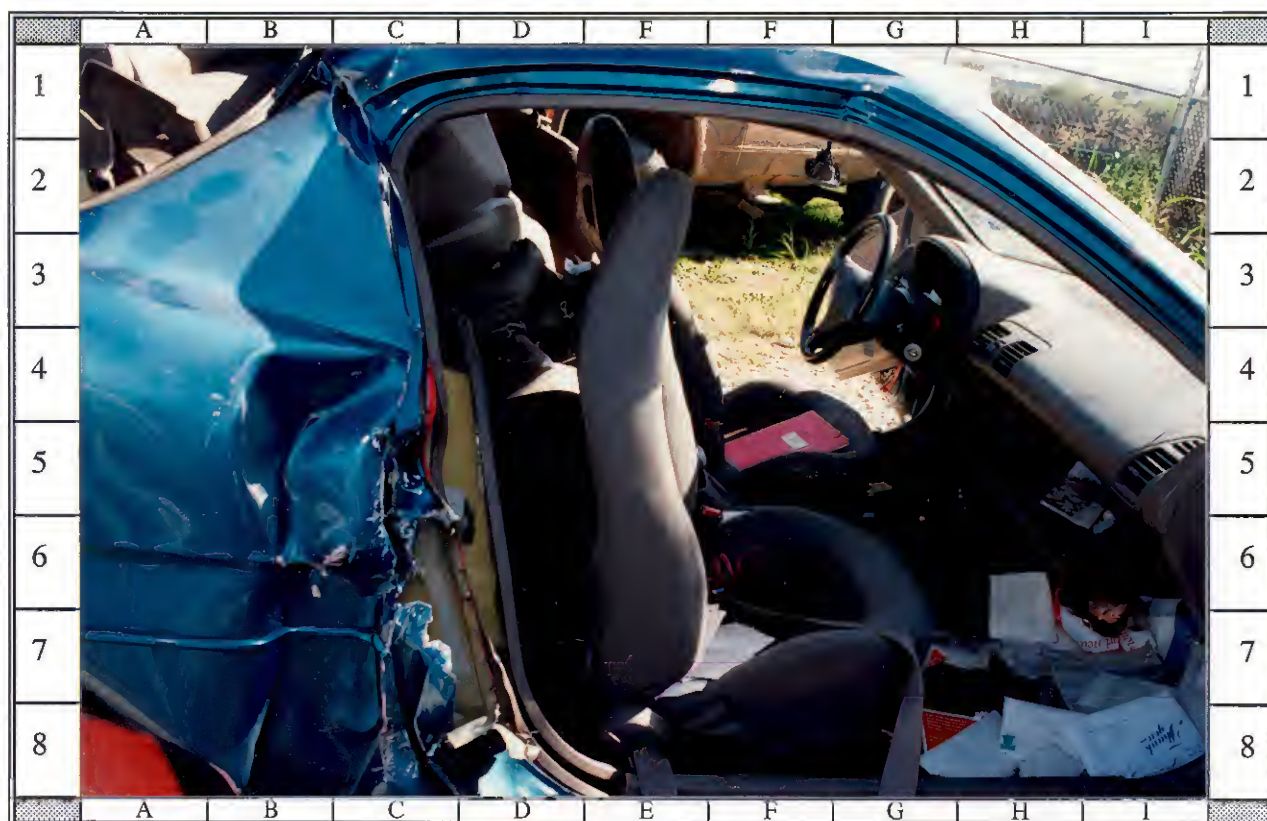
# 55: Case Vehicle's severe back damage and right front passenger seating area viewed from right front showing intrusion to right front seatback

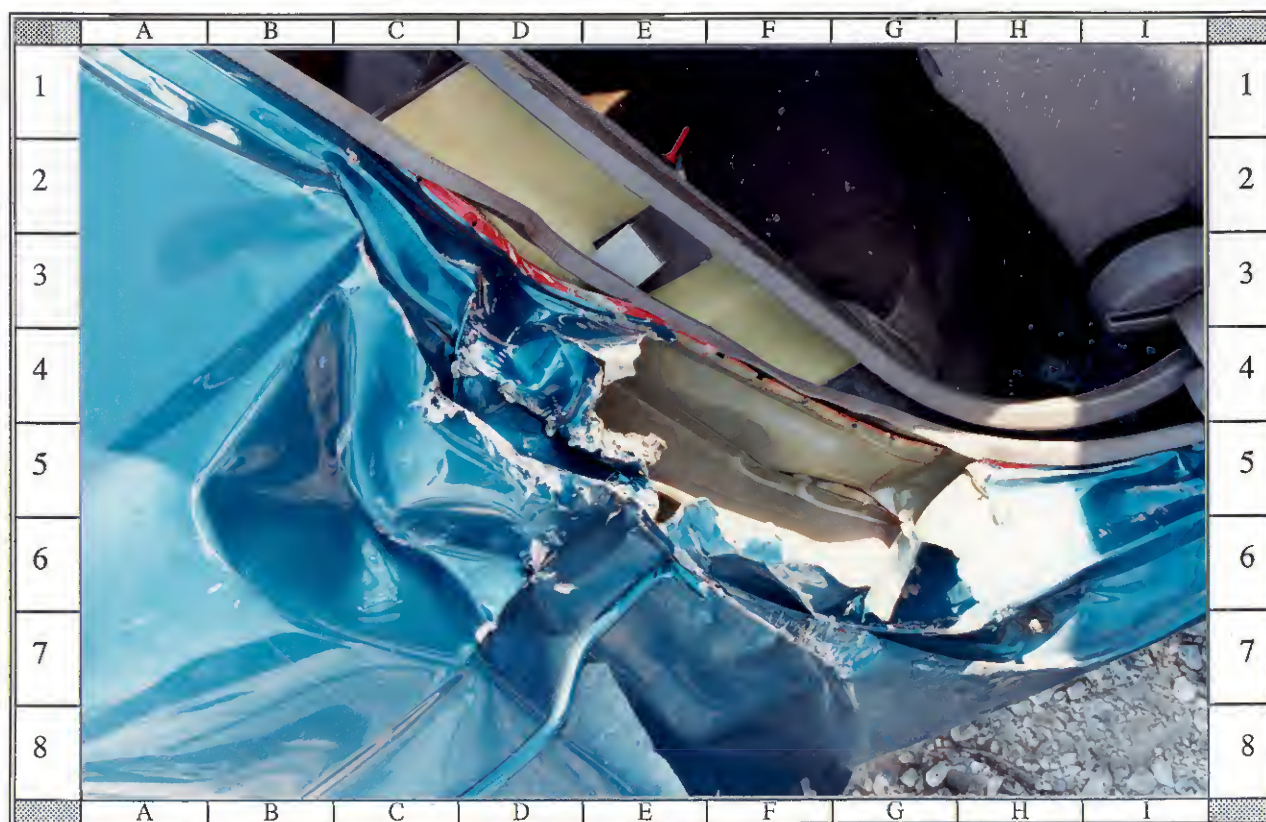
# 56: Closer-up view of Case Vehicle's right front passenger seating area showing intrusion to right front seatback and damaged right "B"-pillar due to extrication

a combination of the rearward impact and the intrusion of the rear seat. It should be noted that in addition to the seat track sliding forward because of the rear impact, the right front passenger's seatback folding locks failed. According to the vehicle inspection and driver's interview, she was also restrained by her available, passive, two-point, motorized, shoulder belt and active, two-point, lap belt.

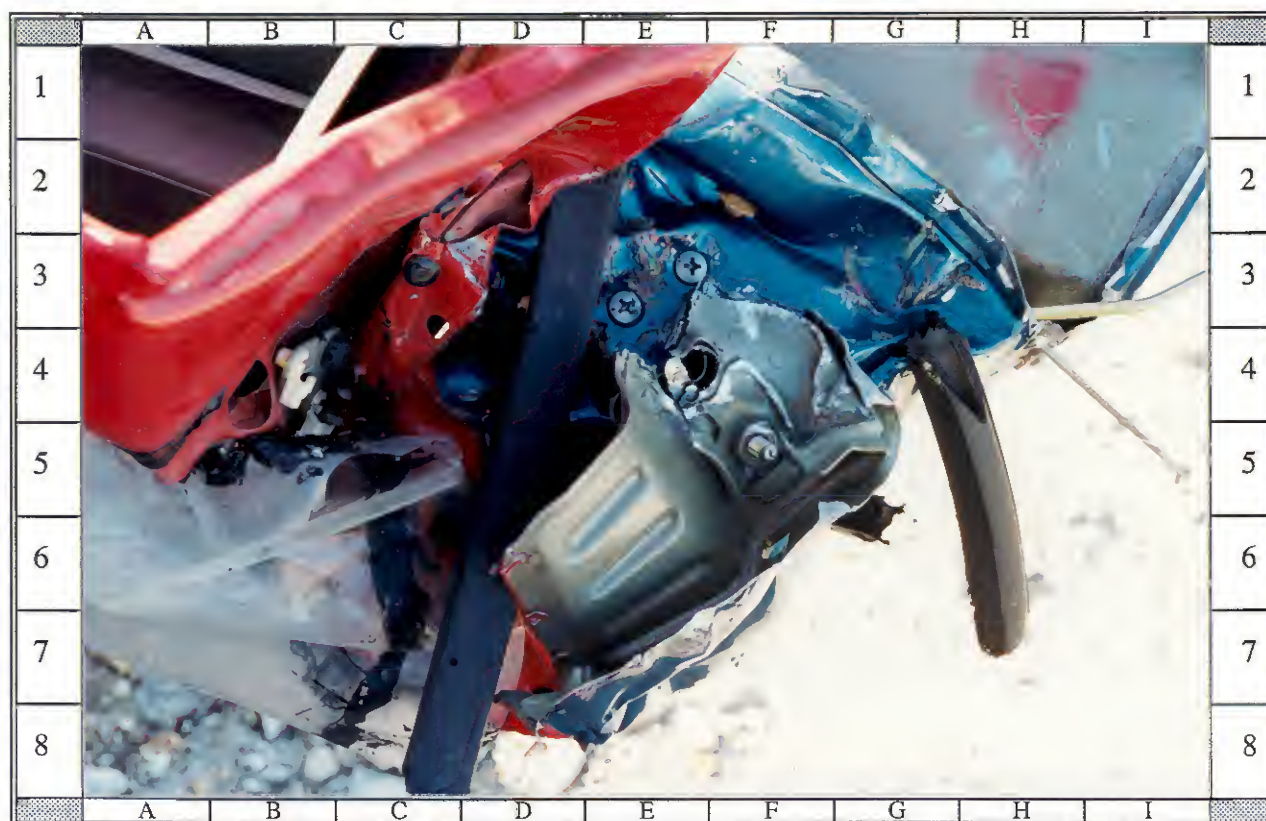
# 57: Close-up of Case Vehicle's missing right front door striker plate which was torn off during extrication

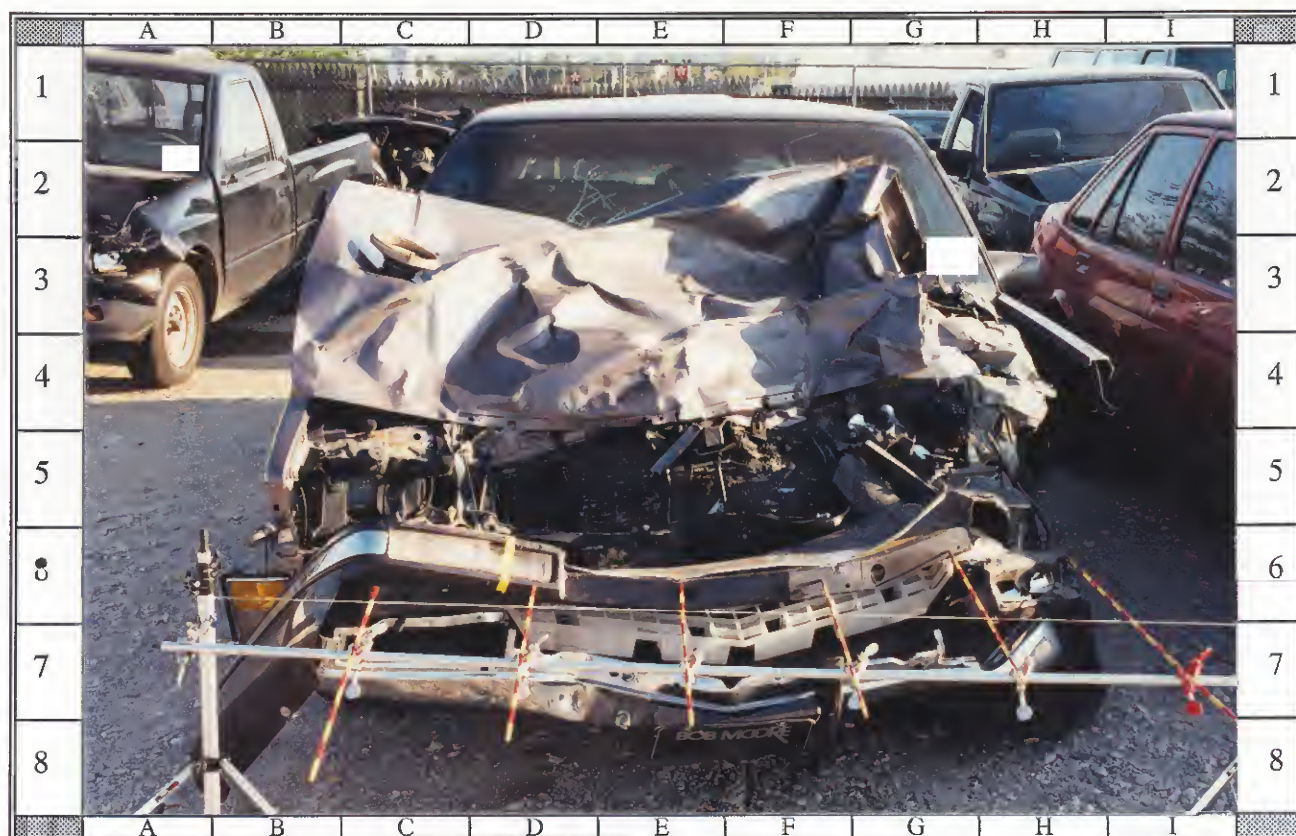
# 70: 1992 Cadillac DeVille's frontal damage without contour gauge present

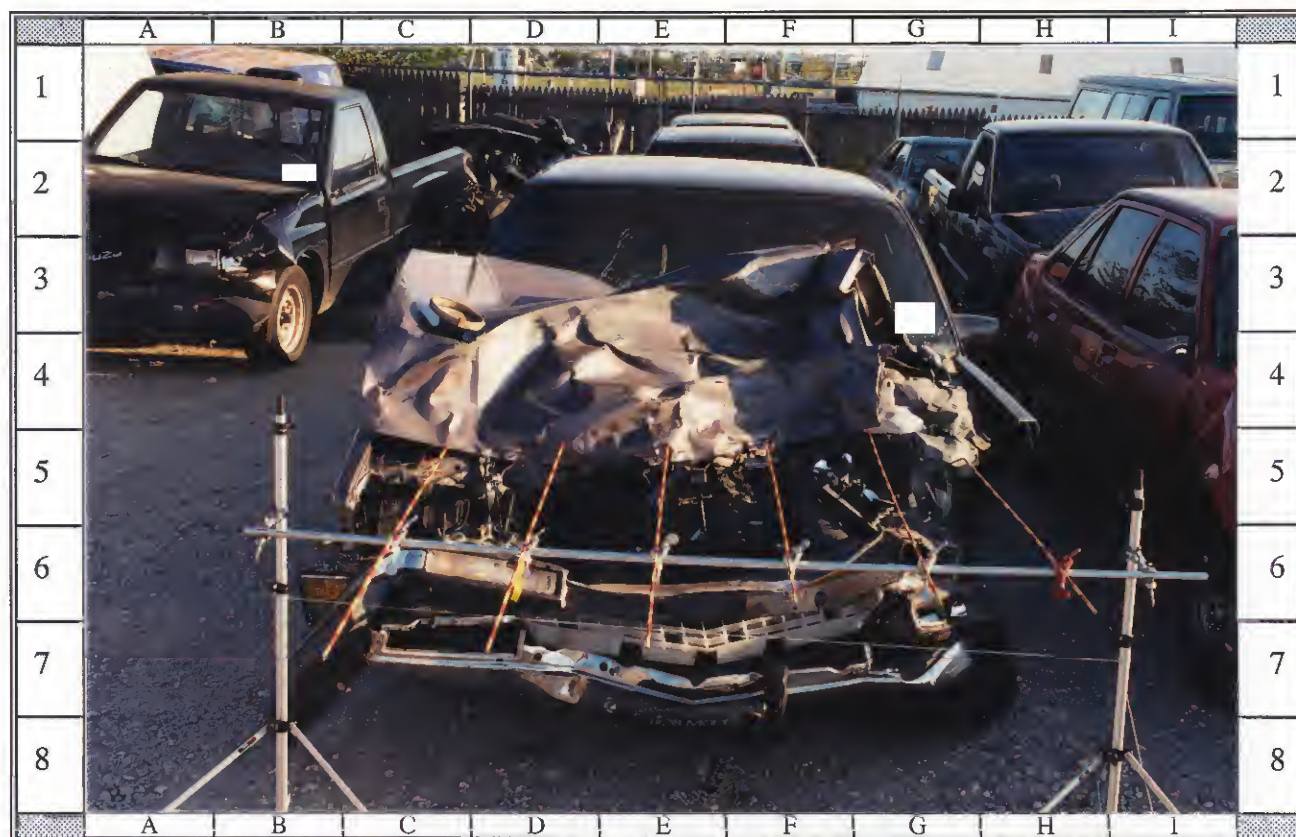
# 71: Vehicle #2's frontal damage with contour gauge showing crush at bumper level

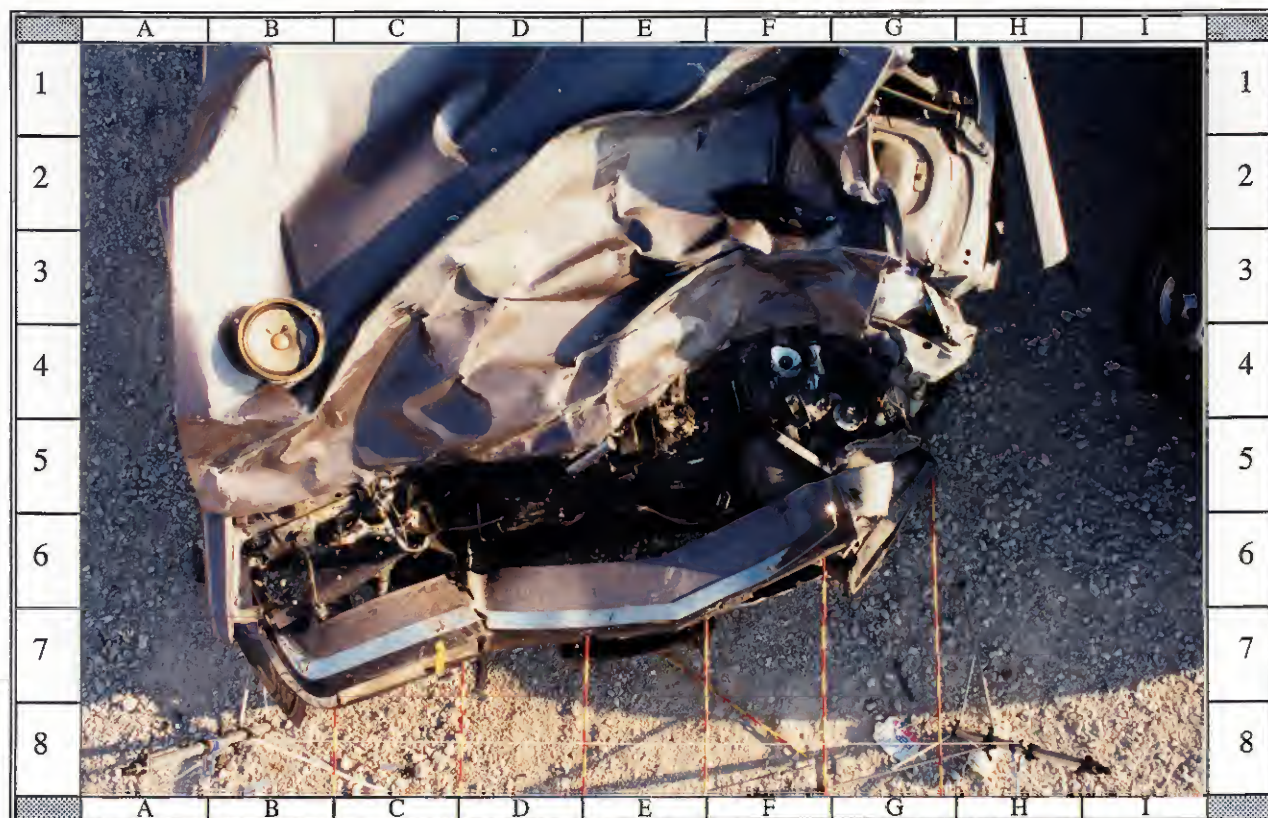
# 72: Vehicle #2's frontal damage with contour gauge showing crush above bumper level

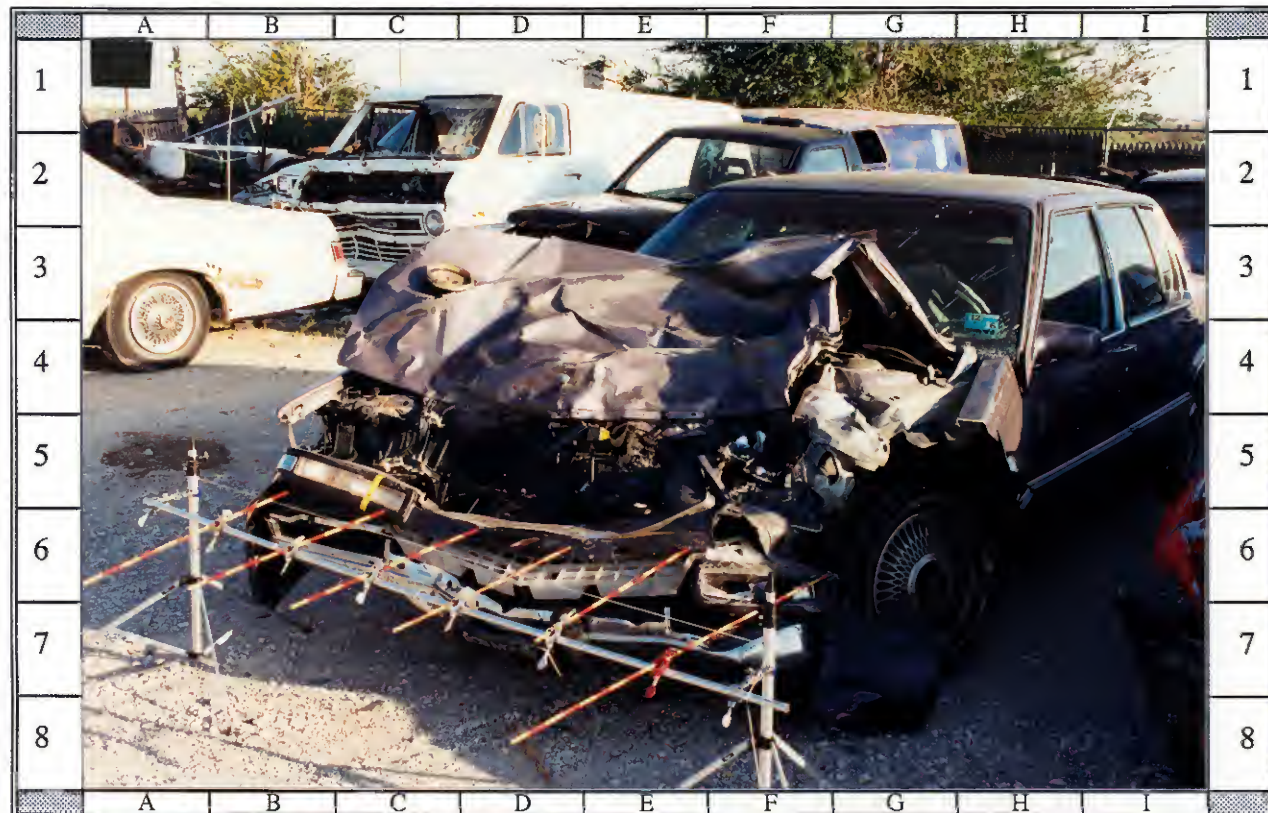
# 73: Overhead view of Vehicle #2's frontal damage; NOTE: uneven damage pattern resulting from underride

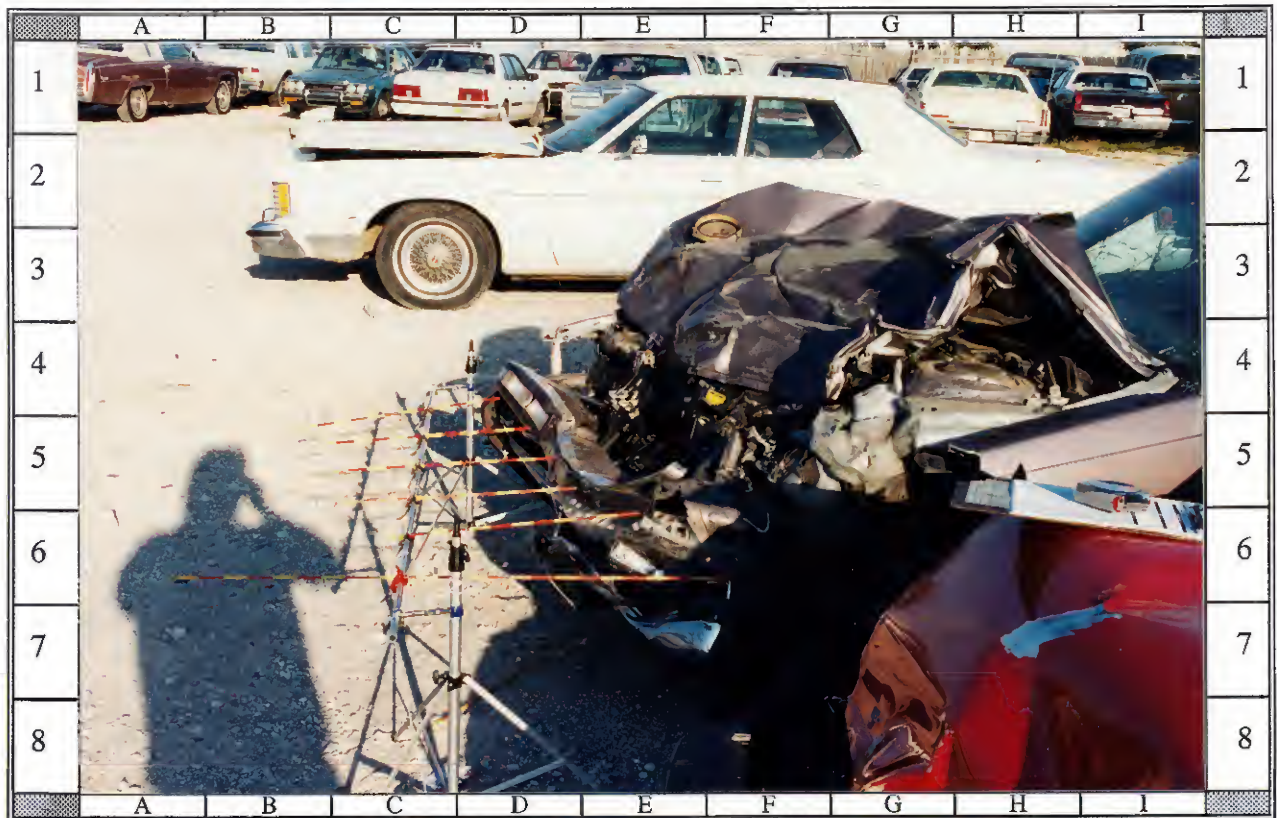
# 74: Vehicle #2's frontal damage viewed from approximately 30 degrees left of front with contour gauge at bumper level

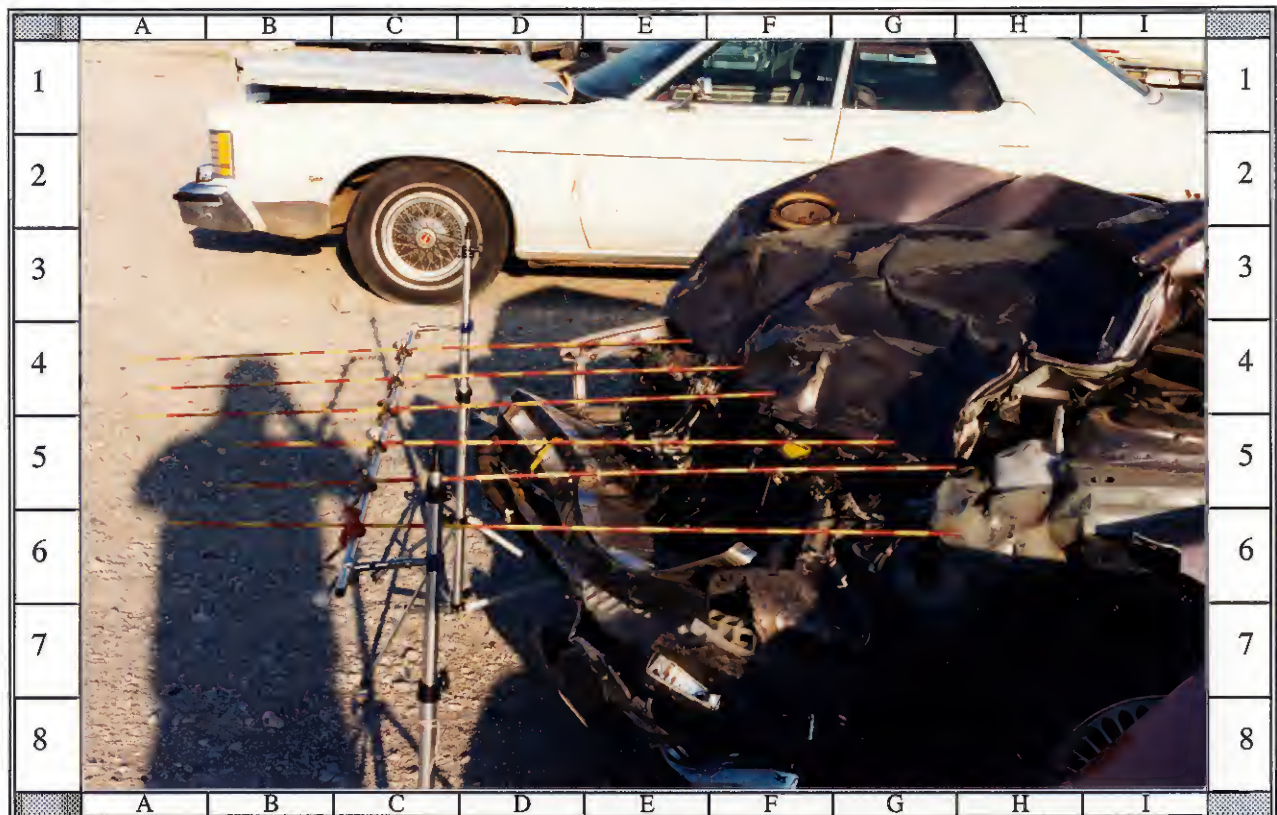
# 75: Reference line view of Vehicle #2's frontal damage from left with contour gauge at bumper level

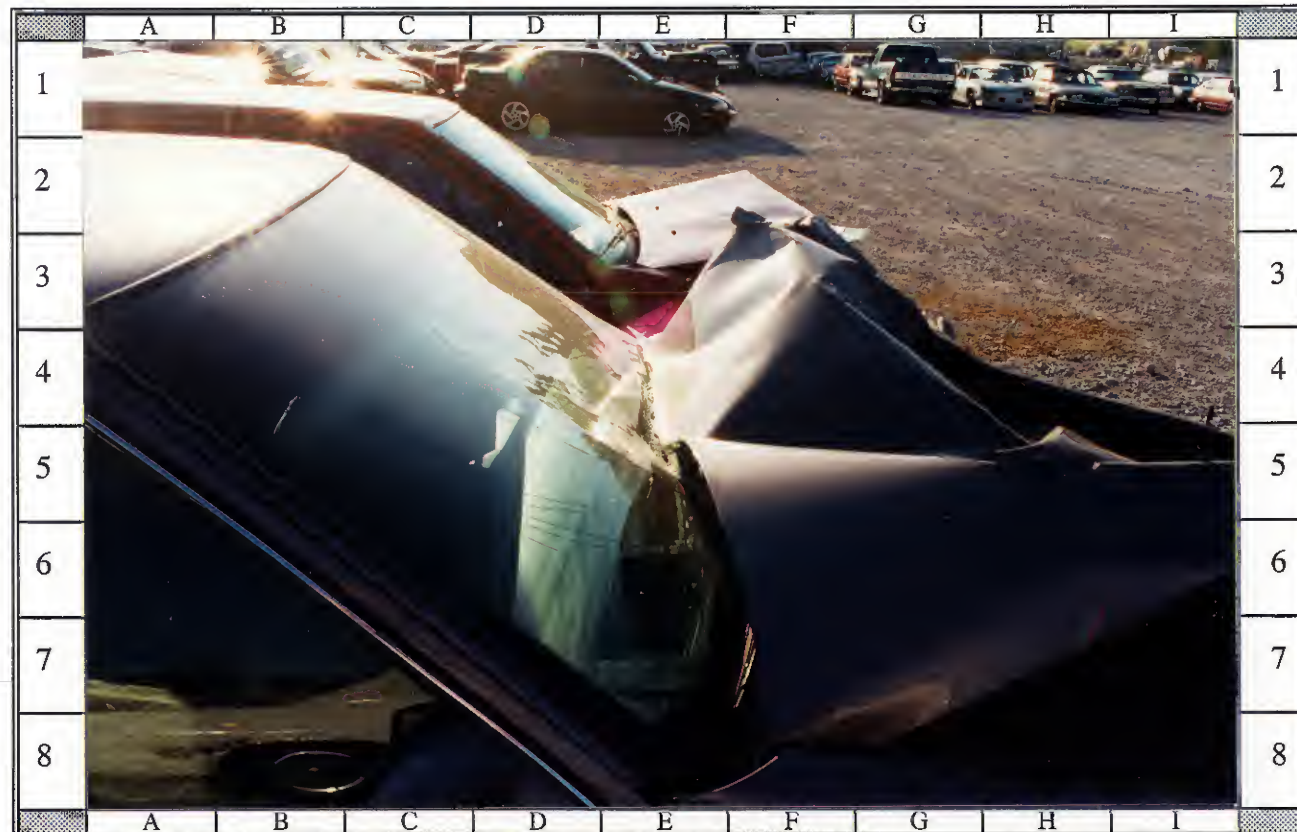
# 79: Vehicle #2's undamaged right side (behind right "A"-pillar) and back viewed from approximately 30 degrees right of back

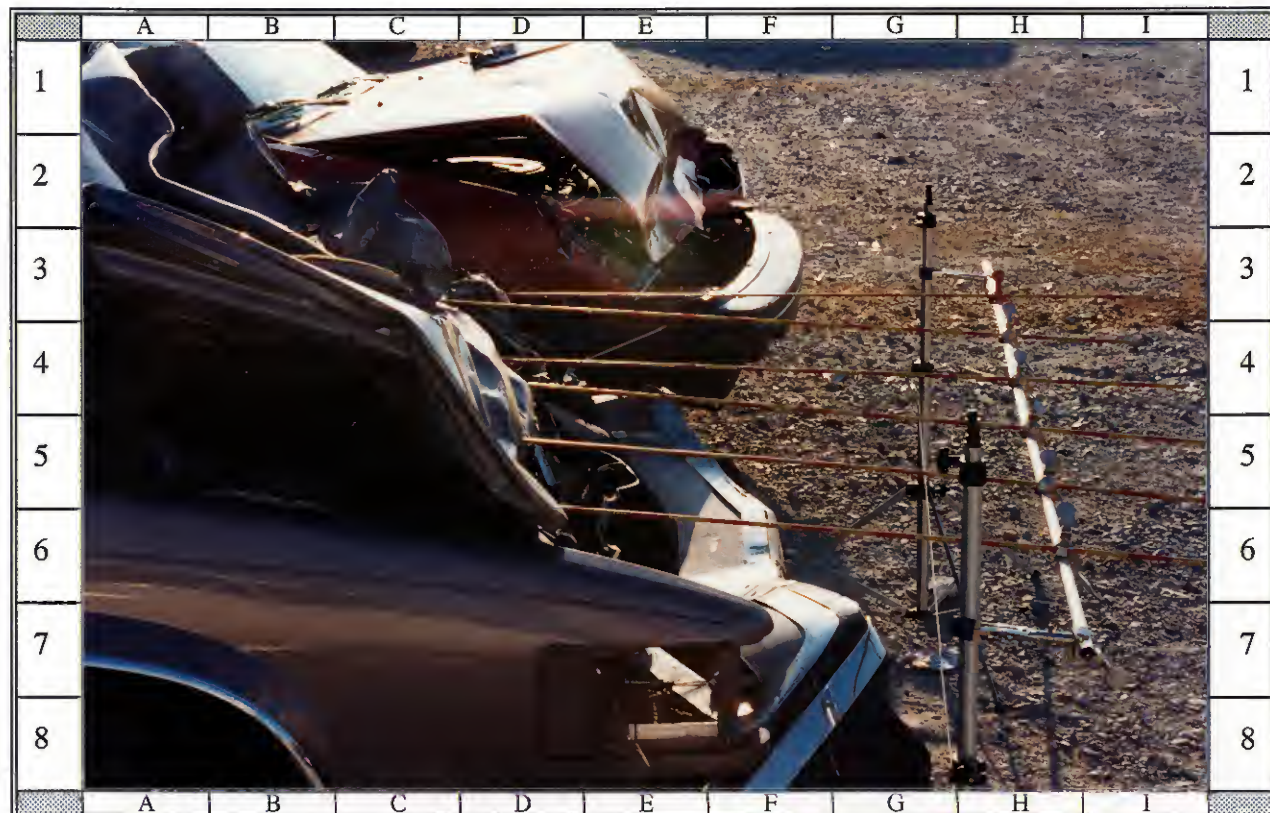
# 81: Reference line view of Vehicle #2's damaged front from right with contour gauge at bumper level

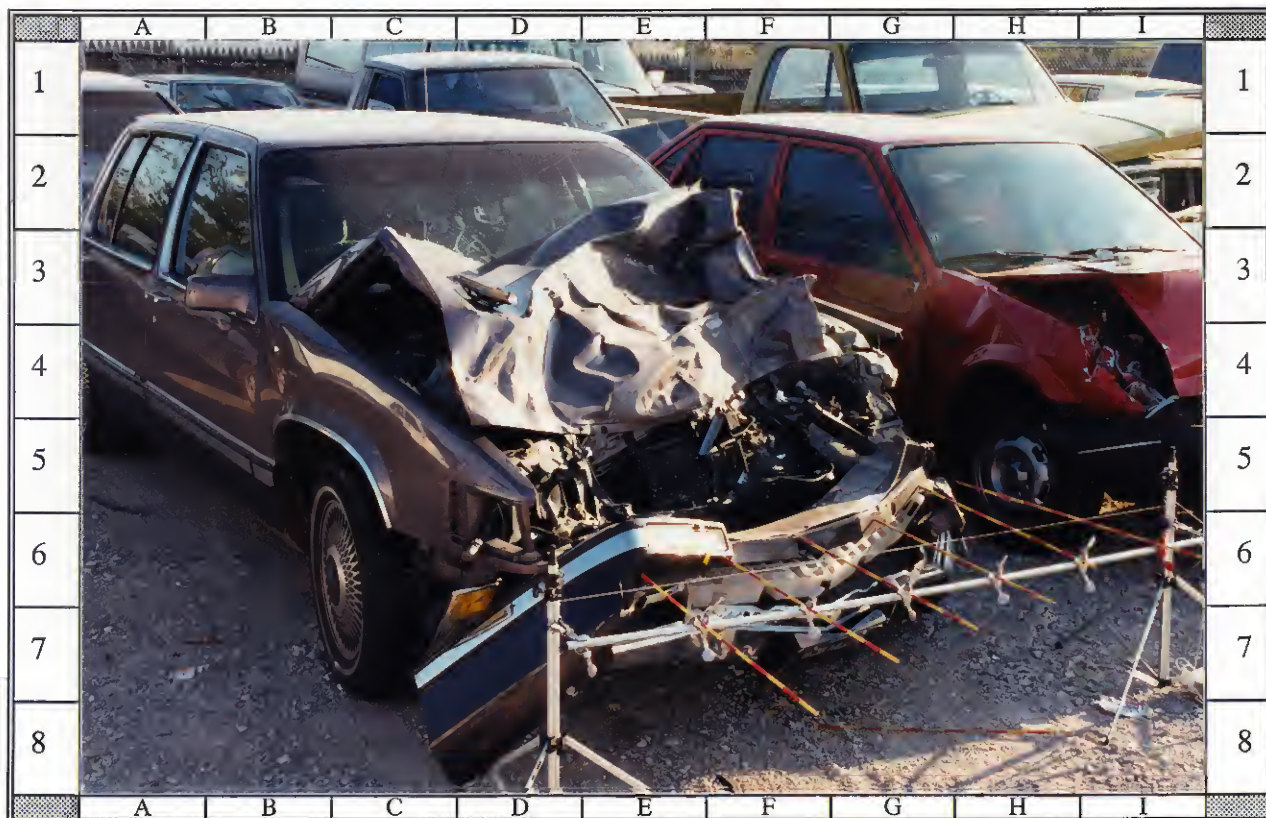
# 82: Closer-up reference line view of Vehicle #2's damaged front from right with contour gauge positioned above bumper

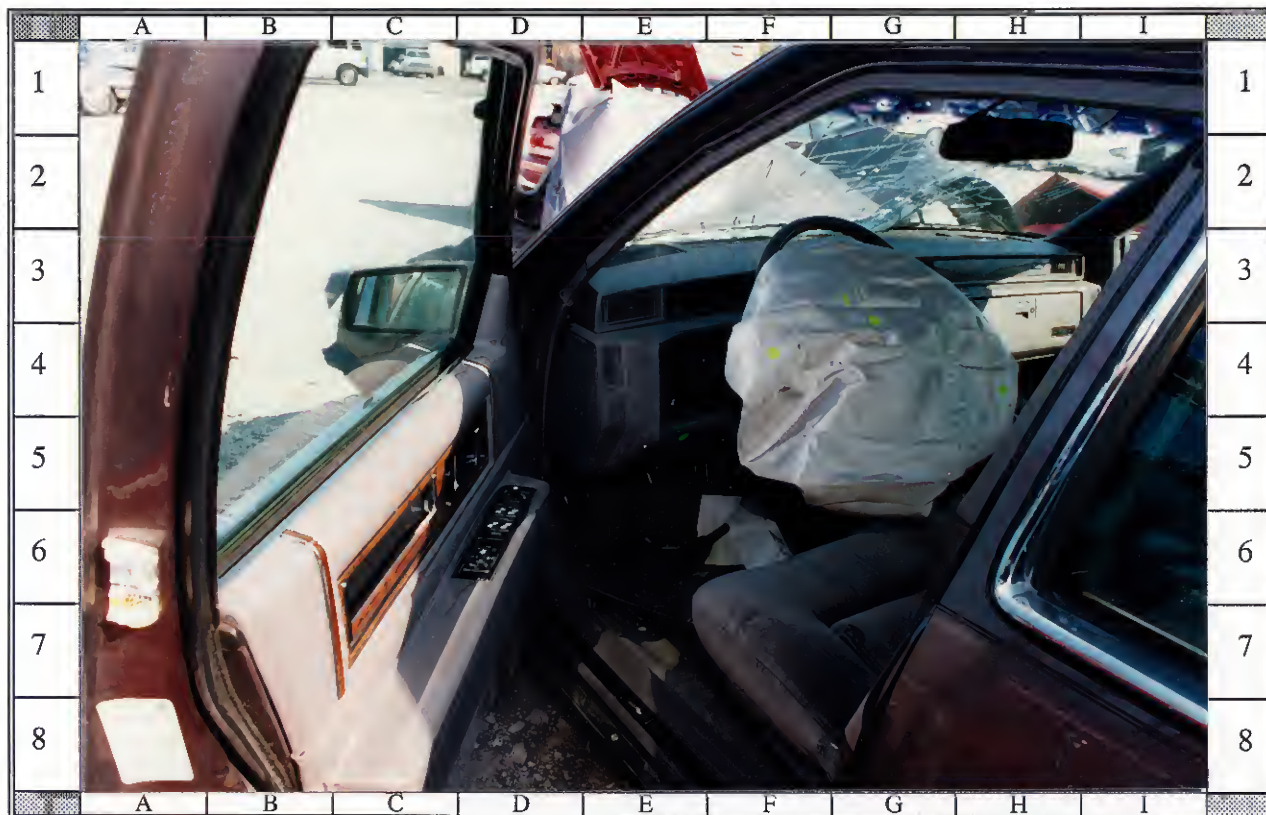
# 83: Vehicle #2's frontal damage with contour at bumper level viewed from approximately 30 degrees right of front

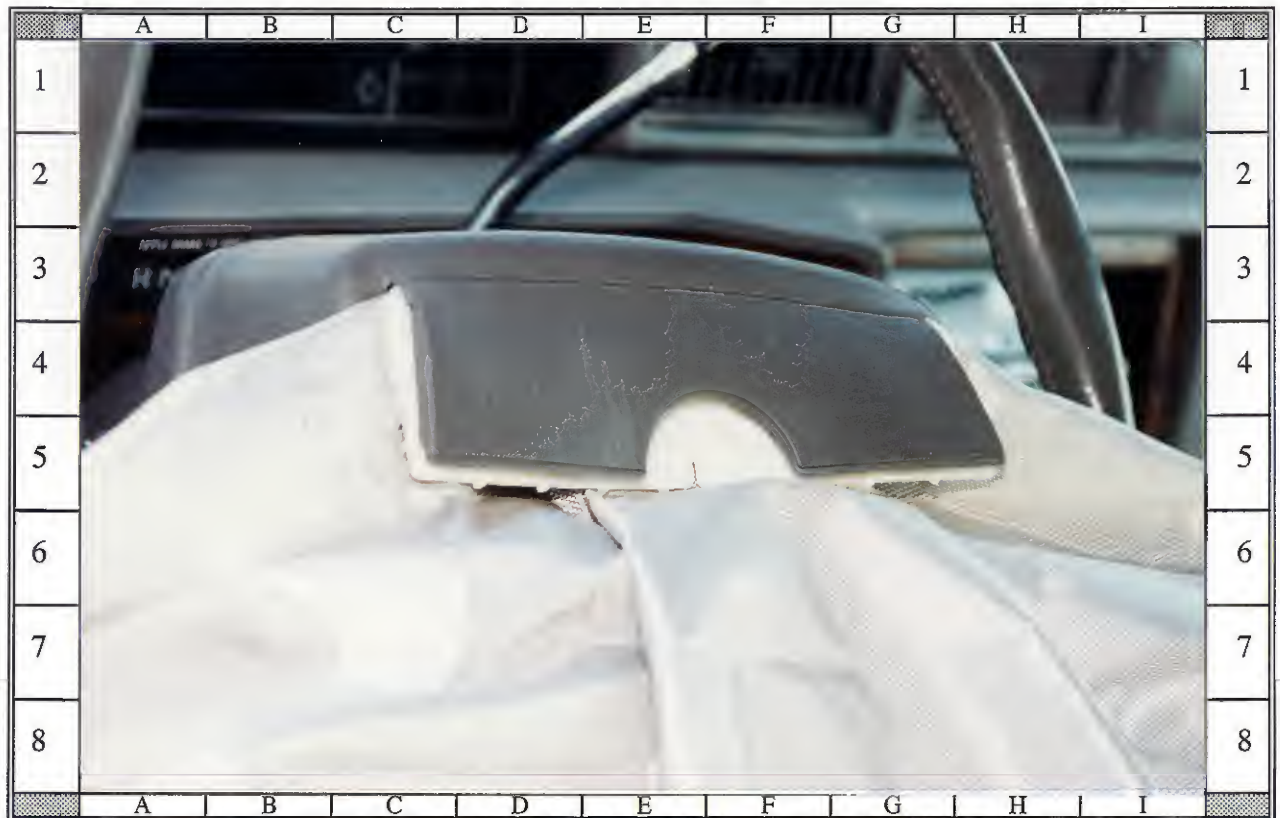
# 86: Vehicle #2's driver side air bag showing areas of contact and blood spots (i.e., green dots); NOTE: windshield cracked by hood (see photograph #80 above)

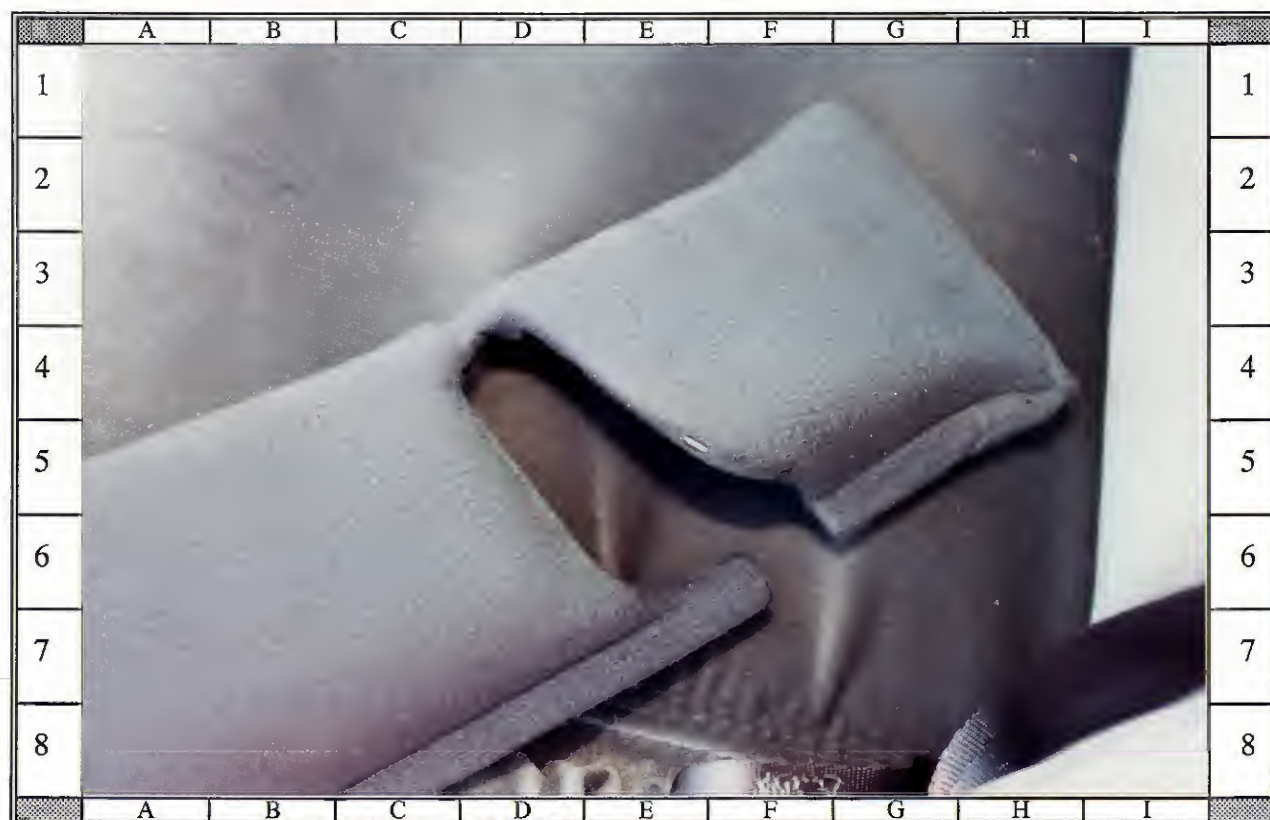
# 88: "D"-ring and left "B"-pillar cover from Vehicle #2's driver side safety belt;  
NOTE: "B"-pillar's cover was removed by this investigator

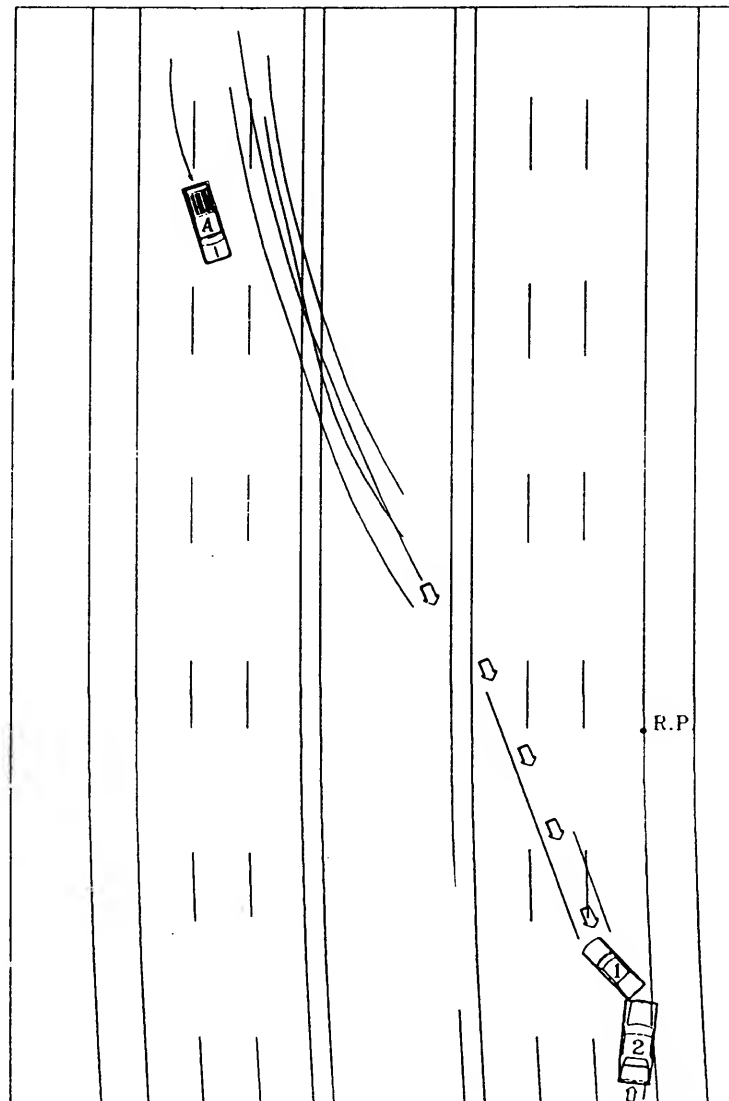
POINT OF IMPACT:  
57 FEET SOUTH OF REFERENCE POINT  
4 FEET WEST OF EAST EDGE OF

TIREMARKS:  
UNIT-1 HAD 180 FEET OF SCUFFS BEFORE IMPACT  
UNIT-2 HAD 18 FEET OF SKIDS BEFORE IMPACT
